# Manhole Inspection Summary

Manhole # S37Y1\_024MH

Insp Date: **11/29/07 12:38 PM**

**Location** Address: **205 Washburn Ave.**

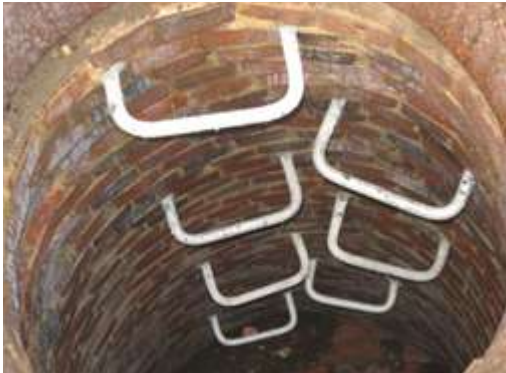
Steps

**Steps** Count: **7** Missing: **0** ☐ Corroded

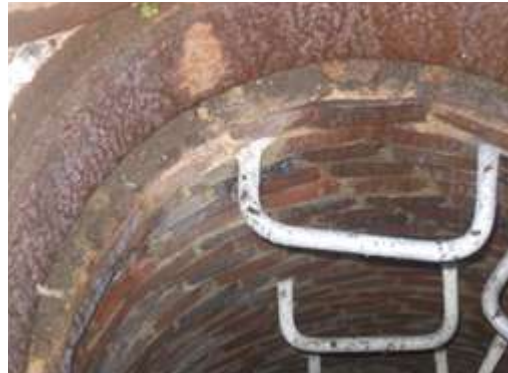
Defect 1

**Frame** Offset: **1** (in.) Condition: ☒ Sound ☐ Cracked ☐ Leaks

Frame offset

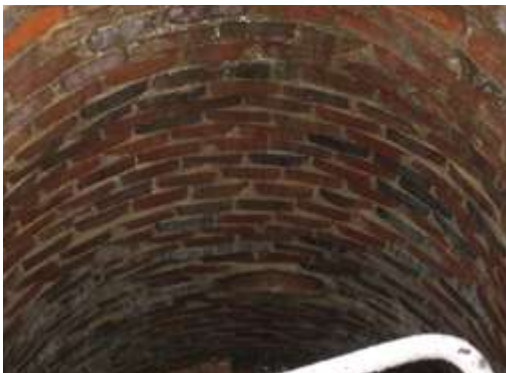
Defect 2

Infiltration: ☐ None ☐ Joint ☐ Cracks ☒ **Mortar** ☐ Roots ☐ Wall

Frame/Chimney joint mortar crack

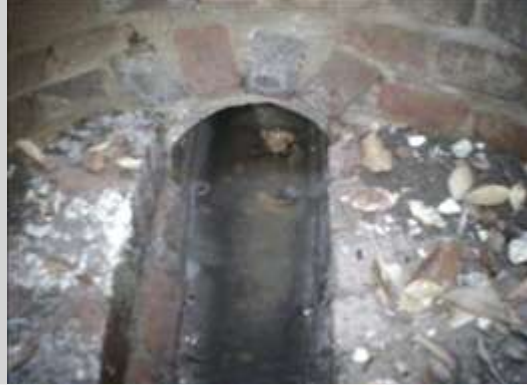
12 O'Clock Outflow

8 in. Circular Gravity Sewer  
Pipe Out @ 12 O'Clock

Pipe Height: **9.6** (in.) Rod and Bar (Angled)  
Pipe Material: **Clay** ☐ Pipe Lined  
Invert Depth: **10.89** (ft.) Flow Characteristics: **Slow**  
Deposits: ☒ None ☐ Mud ☐ Sludge ☐ Debris ☐ Grease  
Silt Depth: (in.) Deposits Extent:  
Infiltration: **None** Pipe Seal Cond: **Sound**

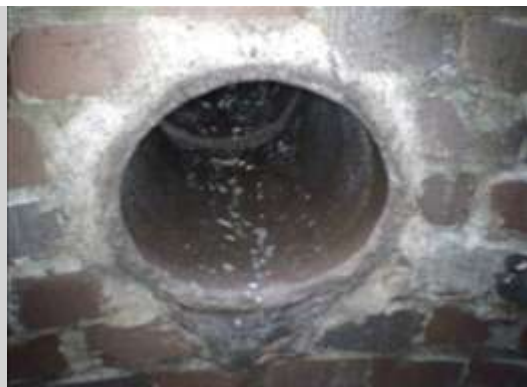
3 O'Clock Inflow

8 in. Circular Gravity Sewer  
Pipe In @ 3 O'Clock

Pipe Height: **9.6** (in.) Rod and Bar (Angled)  
Pipe Material: **Clay** ☐ Pipe Lined  
Invert Depth: **7.58** (ft.) Flow Characteristics: **Fast**  
Deposits: ☒ None ☐ Mud ☐ Sludge ☐ Debris ☐ Grease  
Silt Depth: (in.) Deposits Extent:  
Infiltration: **None** Pipe Seal Cond: **Sound**

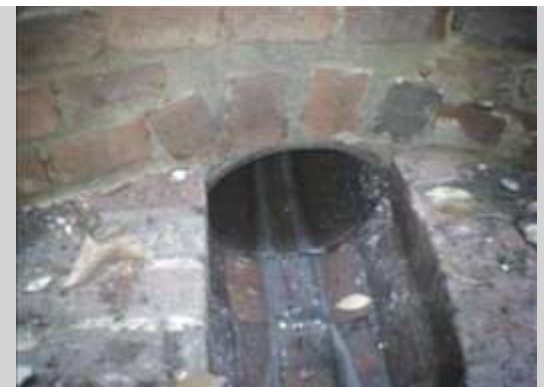
Drop In @ 3 O'Clock

Drop: **Outside** Rod and Bar  
Angled: **Yes** Reading: **9.58** (ft.)  
Inv Depth: **10.58** (ft.)  
Drop Condition: **Open**
